FINAL REPORT

Field Demonstration/Validation of Electrolytic Barriers for Energetic Compounds at Pueblo Chemical Depot

ESTCP Project ER-0519

JANUARY 2010

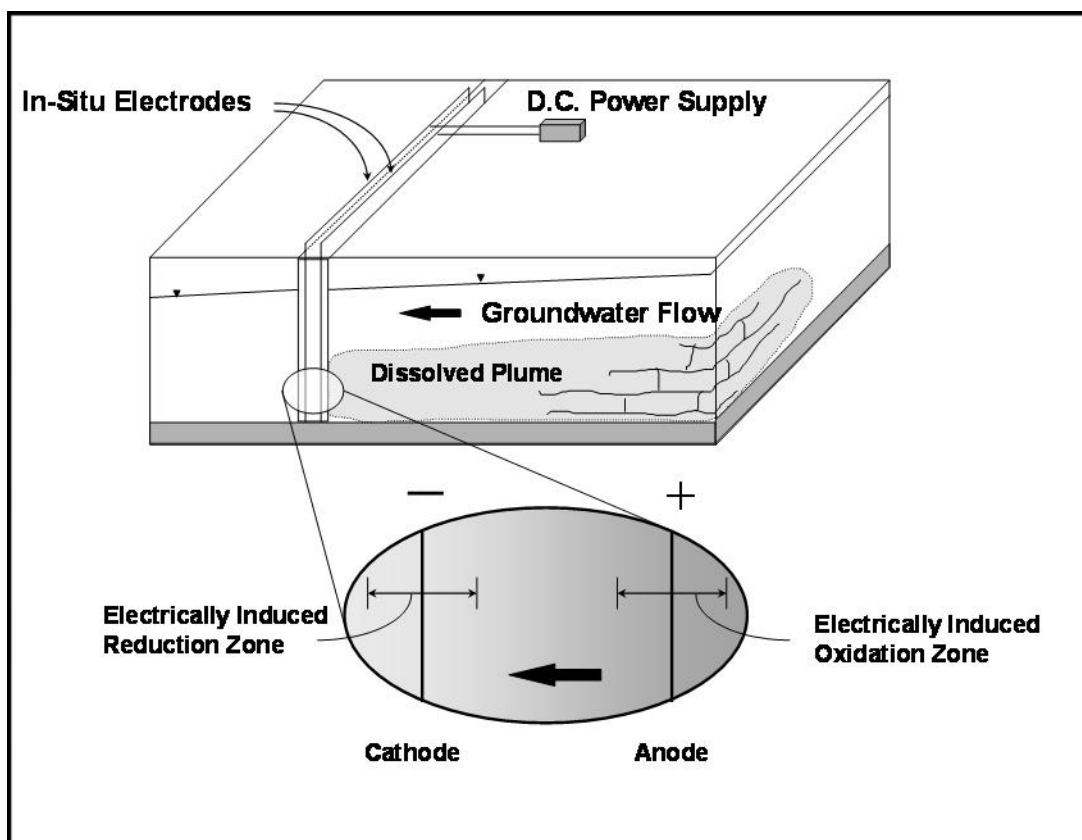
Figure 1 - Conceptualization of a field-scale e⁻barrier.

The e⁻barrier consists of a panel of closely spaced permeable electrodes, which is installed beneath the ground's surface, intercepting a plume of contaminated groundwater. Applying electrical potential to the electrodes imposes oxidizing conditions at the positive electrodes and reducing conditions at the negative electrodes. By imposing sequential oxidizing and reducing conditions, thermodynamic conditions are shifted to drive the transformation of target compounds to non-toxic products. A field-scale conceptualization of an e⁻barrier is illustrated in Figure 1.

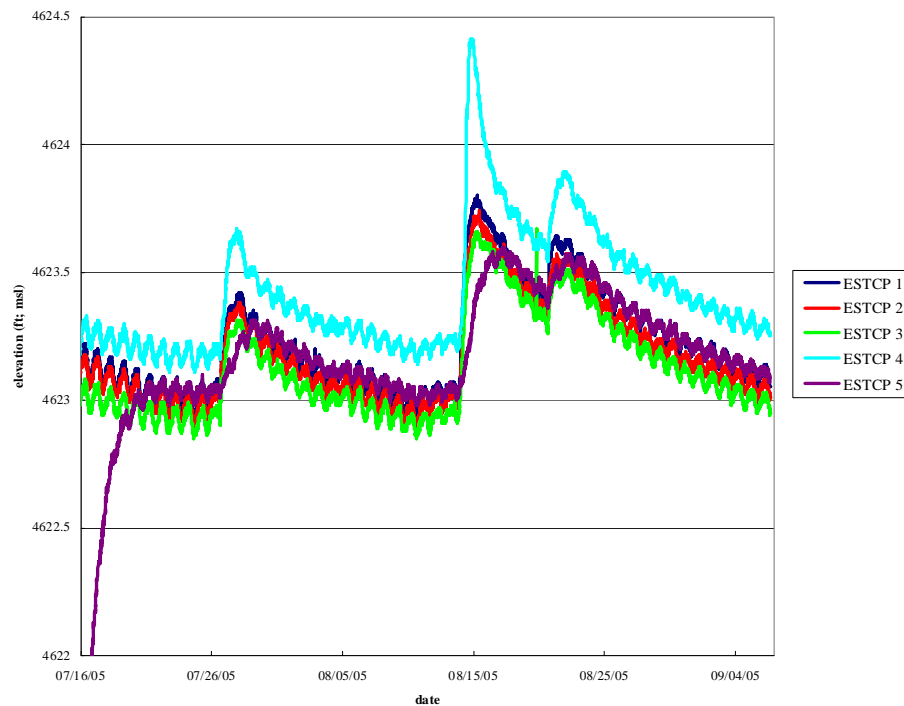
Figure 13 - Pre-demonstration hydrographs from temporary wells .

Water Levels – In July 2005, five data logging pressure transducers (Solinst Levellogger Model 3001) were installed in wells ESTCP 1-3, ESTCP 5 and ESTCP 11 to record water table elevation in the proposed footprint of the demonstration barrier. Barometric correction was conducted *a posteriori* using data collected from a Solinst Barologger Model 3001 installed under atmospheric conditions in ESTCP 11. Hydrographs are included in Figure 13.

- Periodic increases in water levels correspond with precipitation events
- Precipitation events cause brief periods when the gradient through the area increases
- The ordering of well elevations (high to low) and differences in water level elevations between wells generally remain the same, suggesting a constant flow direction gradient.

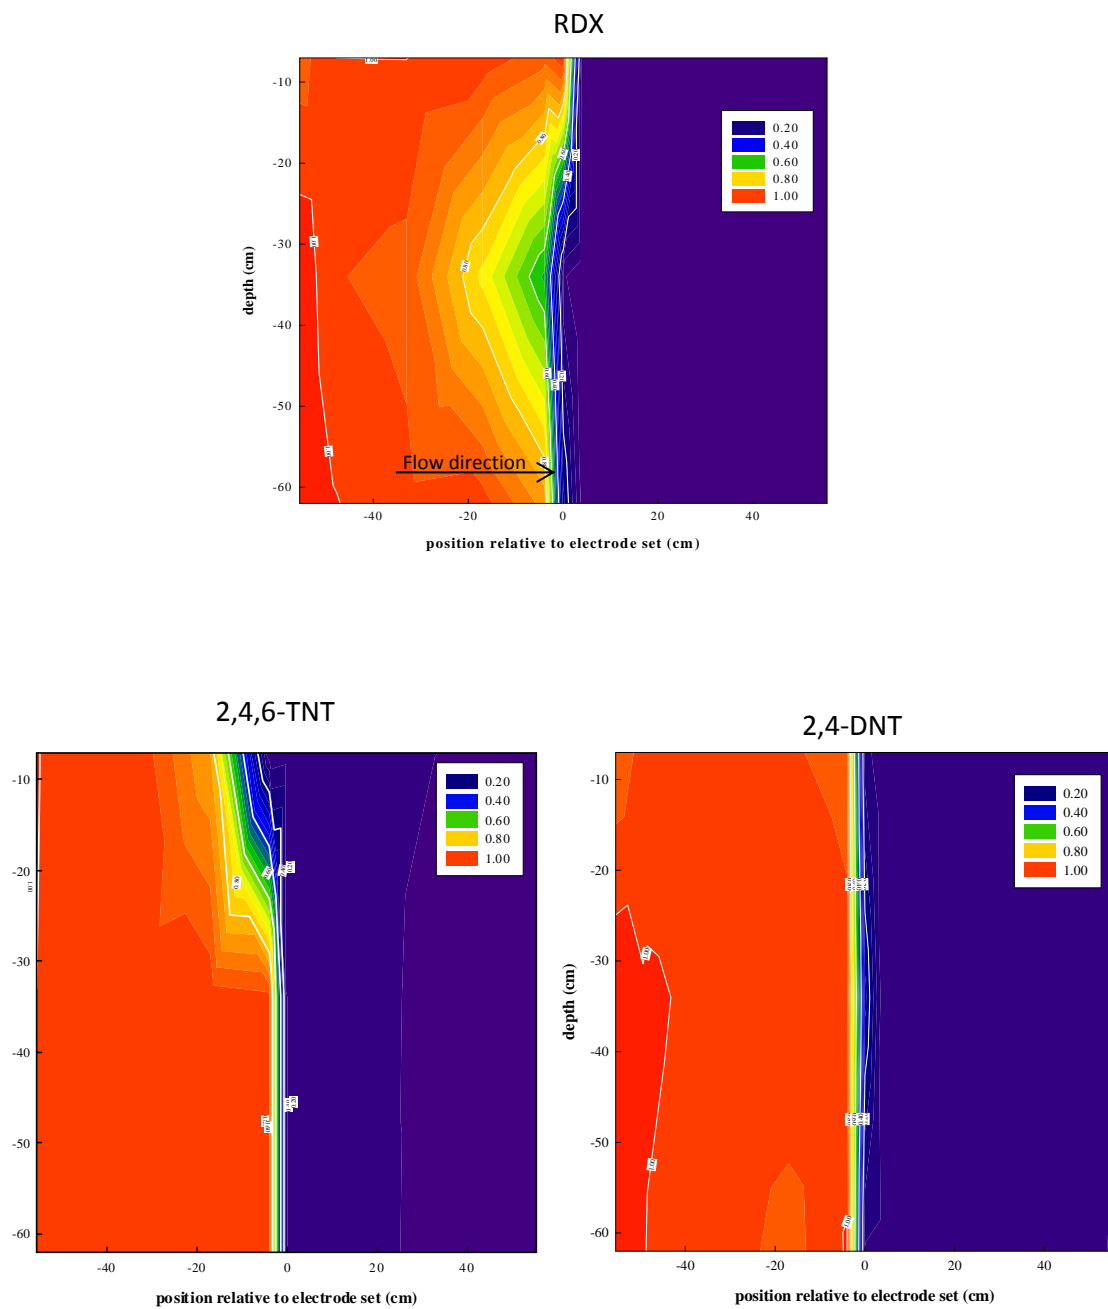
Figure 21 - Influent-normalized concentrations as a function of position in the 2-D tank study for RDX (upper), 2,4,6-TNT (lower left), and 2,4-DNT (lower right). Position 0 is the center of the electrode pack. Degradation of RDX is noted upgradient of the barrier.

Tank Study Results - Overall results from the 2-D tank studies are consistent with those observed in the column experiments. Overall conversions achieved for RDX, 2,4,6-TNT, and 2,4-DNT were 90, 96, and 93%, respectively. Two-dimensional concentration profiles are presented in Figure 21. Concentration distributions in two dimensions suggested that the barrier's height may have an influence on RDX concentrations upgradient of the e⁻ barrier. The hypothesis is that these low concentrations are the result of back mixing due to the formation of convection cells, which are formed by gas generation at the electrode surfaces. 2,4,6-TNT and 2,4-DNT do not appear to exhibit this effect. High nitrate levels did not appear to affect treatment performance either.

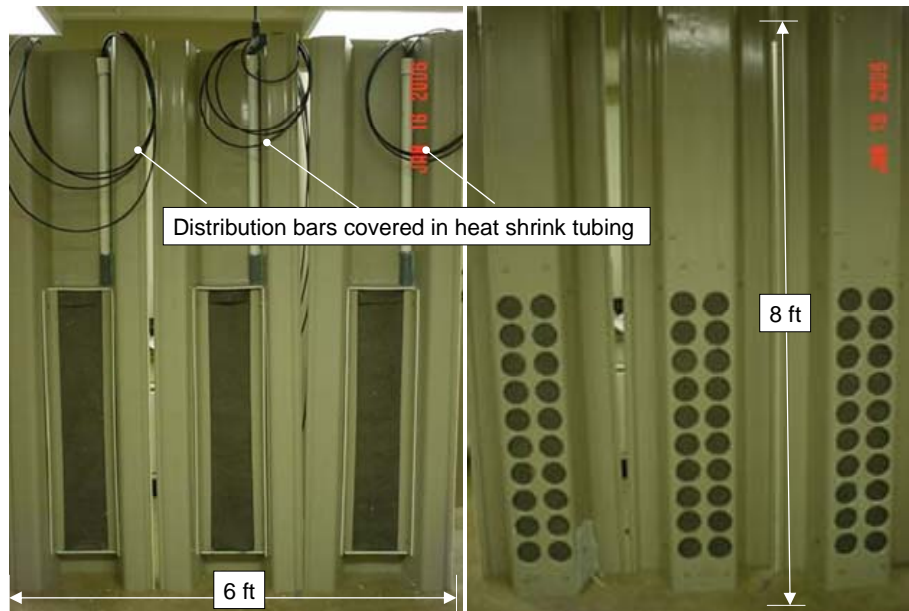
Figure 23 - Assembled e-barrier panels upstream side (front) and downstream (back).

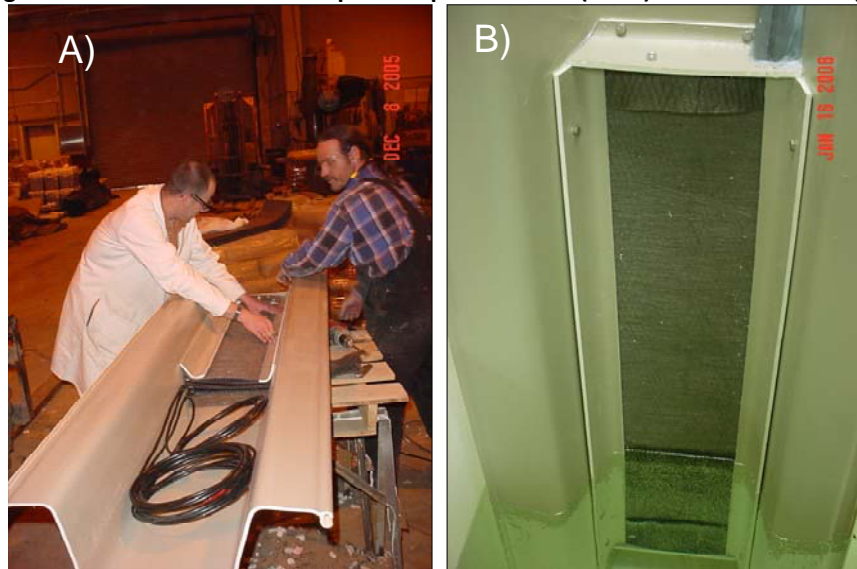
Figure 24 - A) Attaching composite electrode panels to the vinyl sheet pile and B) testing a fabricated section of the e-barrier in a water bath for electrical performance.

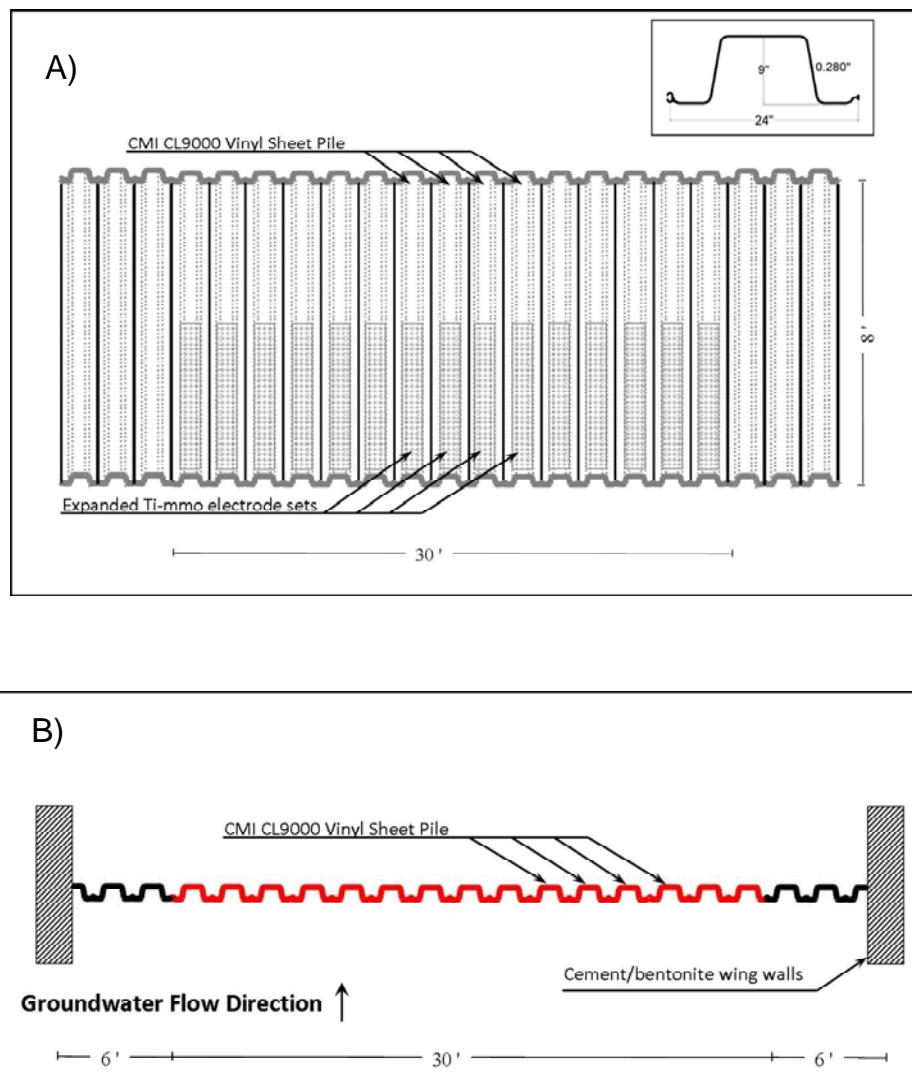
Figure 25 - A) Cross-section of e-barrier as fabricated and B) envisioned field installation in plan view.

A total of 15 active electrode panels were constructed. Three blank sheet pile sections were placed at each end of the barrier. The blank portions were used to tie in the bentonite wing walls in the field. Figure 25 illustrates the e-barrier in cross-section and the envisioned field installation. The role of the bentonite wing wall was to limit flow around the e-barrier. Flow around the end of the barrier had been a limiting aspect of an earlier e-barrier demonstration conducted at F.E. Warren AFB, WY (CU-0112).

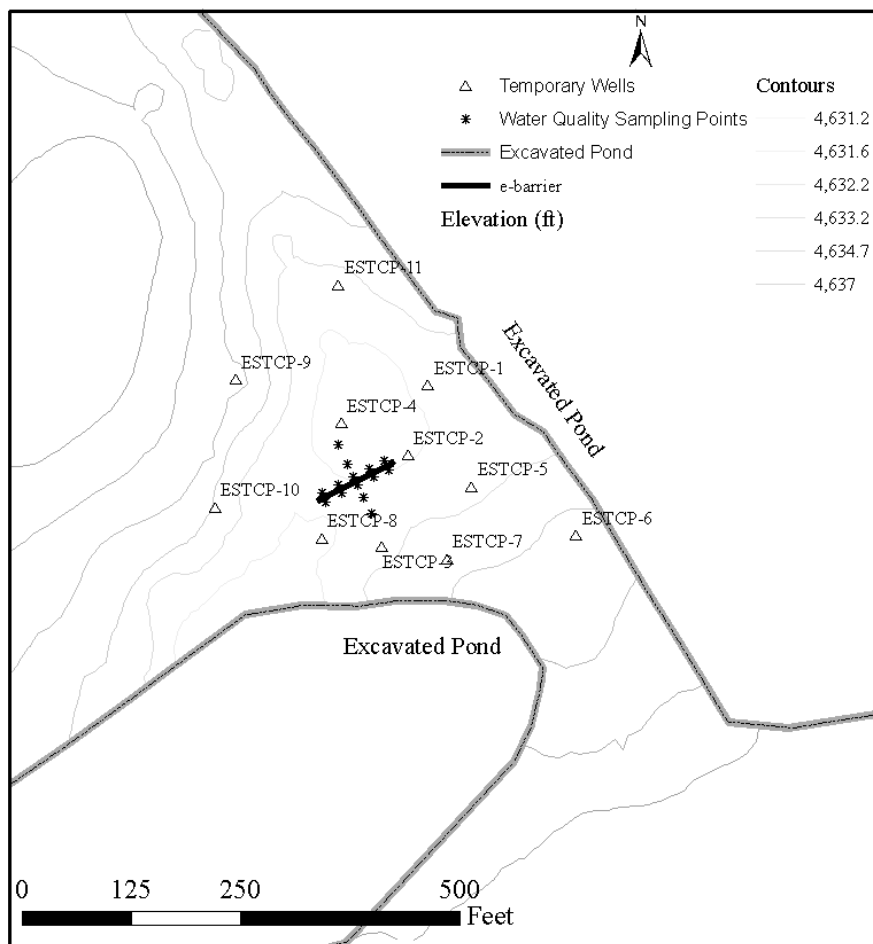
Figure 29 - As-built alignment of the e-barrier.

The as-built alignment of the e-barrier based on a post-installation survey is presented in Figure 29. A profile depicting the elevation of the individual sheet pile section is presented in Figure 30.

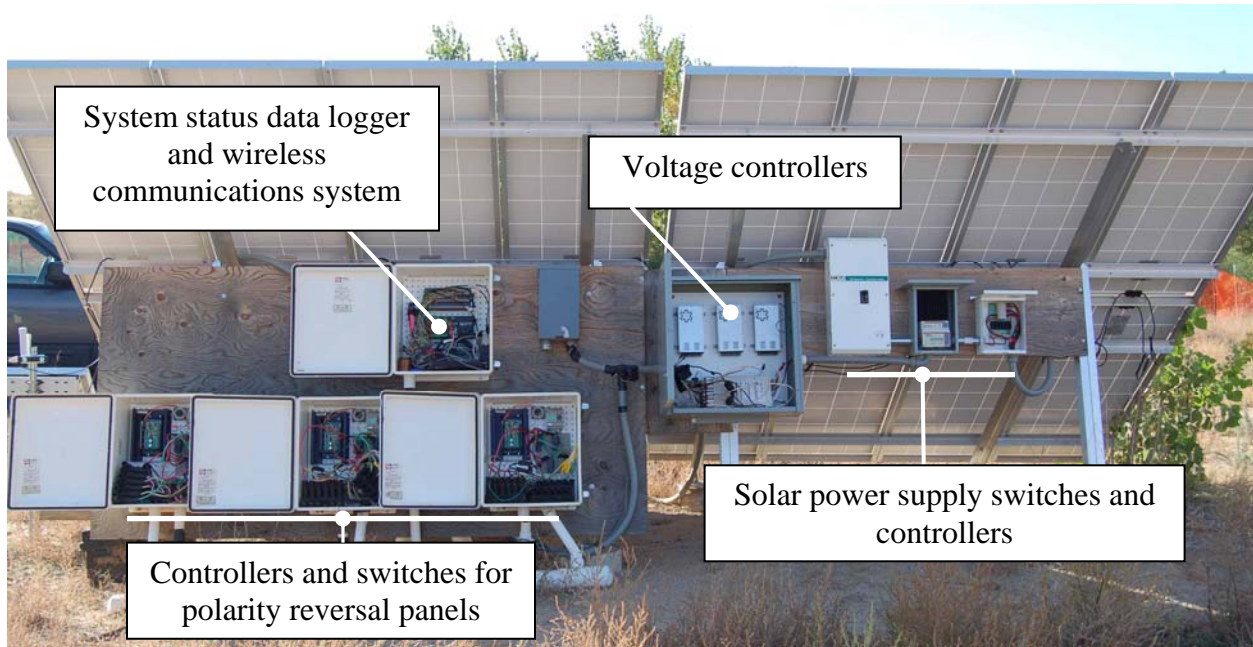
Figure 33 - Electrical controllers and data logging systems.

- The box in the upper left-hand corner contains a multi-channel data recorder with wireless modem (Campbell Scientific, Logan UT). The system records applied voltage, resultant current to each active barrier module, and electrode potential relative to reference electrodes. The reference electrodes (Corrpro, Medina OH) were buried at the center panel adjacent to the up-and down-gradient faces of the e-barrier. Data was collected in 15-minute intervals and downloaded to CSU via a wireless connection on a daily basis. This system operated reliably until December 2007. Applied voltage, reference electrode potential, and current are presented in Figure 35 and Figure 36. Although data was collected after this point, we have been unable to transform the data collected to the parameters of interest. The problems may have to do with the low power issue noted in the prior bullet.

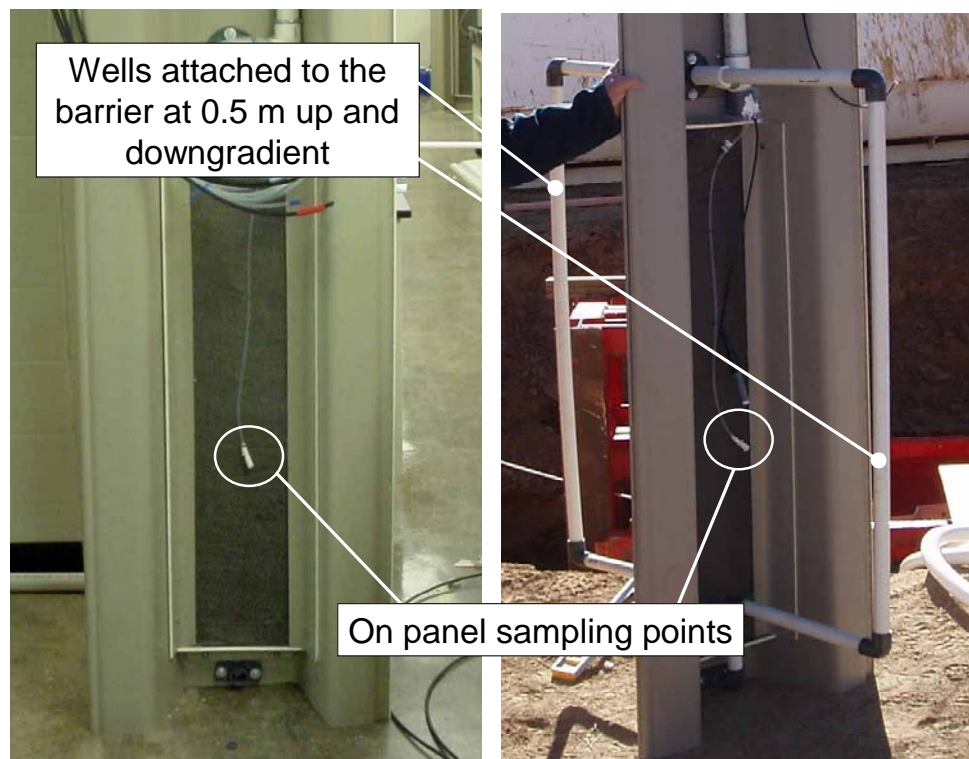
Figure 37 - Water quality sampling point attached to the e-barrier.

Photos of the on-face sampling points and the 0.5 m wells (attached to the barrier) are presented in Figure 37. The sampling points on the panel face were constructed of 6.35 mm ID Teflon tubing and a NytexTM cloth screen. Samples were pulled from the 0.5 m wells via a 6.35 mm ID Teflon tube. The sample points attached to the e-barrier panels (i.e., on-face and at 0.5 m, as shown in Figure 37) are located in backfill material (section 4.4). The wells at 2 and 4 m are located in the natural alluvial sands. Figure 38 illustrates the position of sampling points in cross-section and plan view.

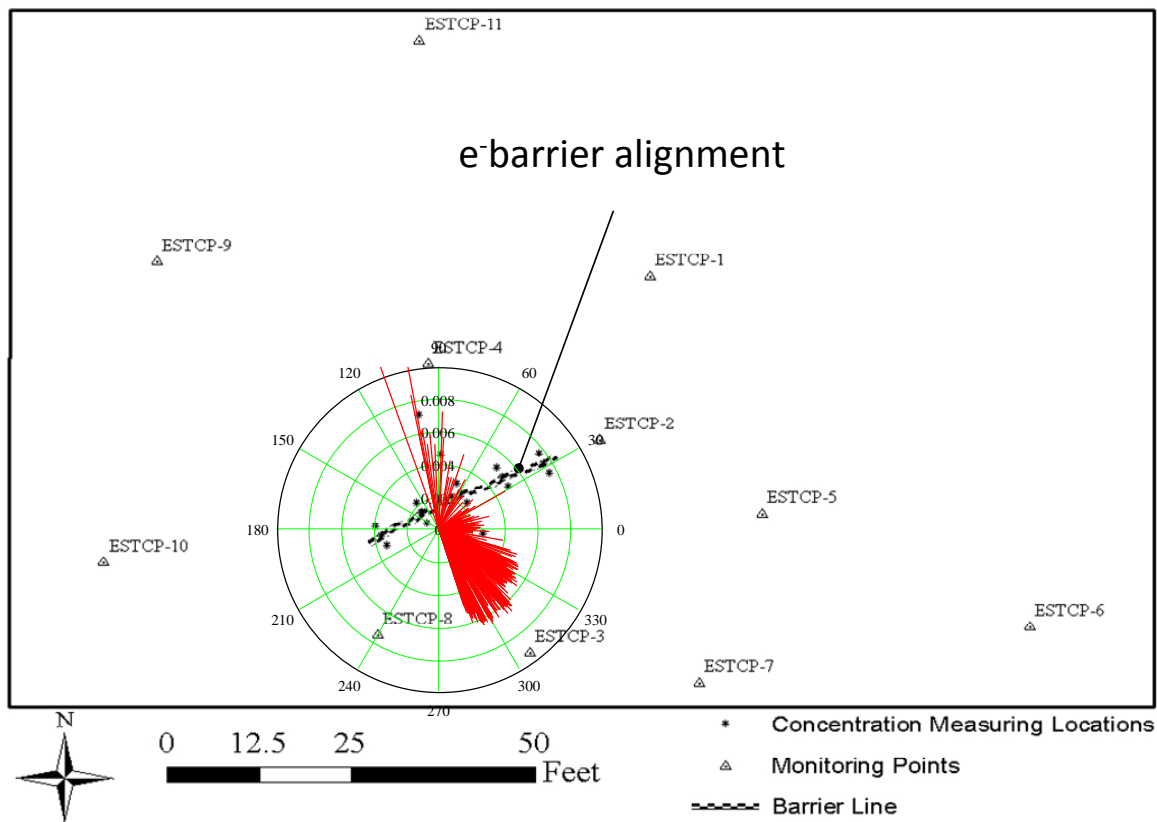
Figure 40 - Vector plot illustrating the direction of groundwater flow and the magnitude of the gradient for March 2006 through October 2008.

Using the data from ESTCP 6, ESTCP 8, and ESTCP 11 (the wells that are farthest apart) the daily direction of groundwater flow and the magnitude of the hydraulic gradient were resolved for the available data sets. Figure 40 presents a vector plot illustrating magnitude and direction of groundwater flow. Figure 41 and Figure 42 plot the direction of flow and hydraulic gradient, respectively, as a function of time. During the recorded period, the mean direction of flow is to the southeast (36 degrees south of due east) with a standard deviation of 31 degrees. Using the same data, the mean gradient is 0.0041 with a standard deviation of 0.0015. Overall, the flow is largely perpendicular to the e-barrier. Variance from the southeast flow direction is attributed to infiltration from high intensity summer thunderstorms. Using the high estimate of hydraulic conductivity from Section 5.1.3 of 0.015 cm/sec, a formation porosity of 0.25, and the observed gradients, the seepage velocity in the vicinity of the e-barrier is 250 ± 93 0.25.

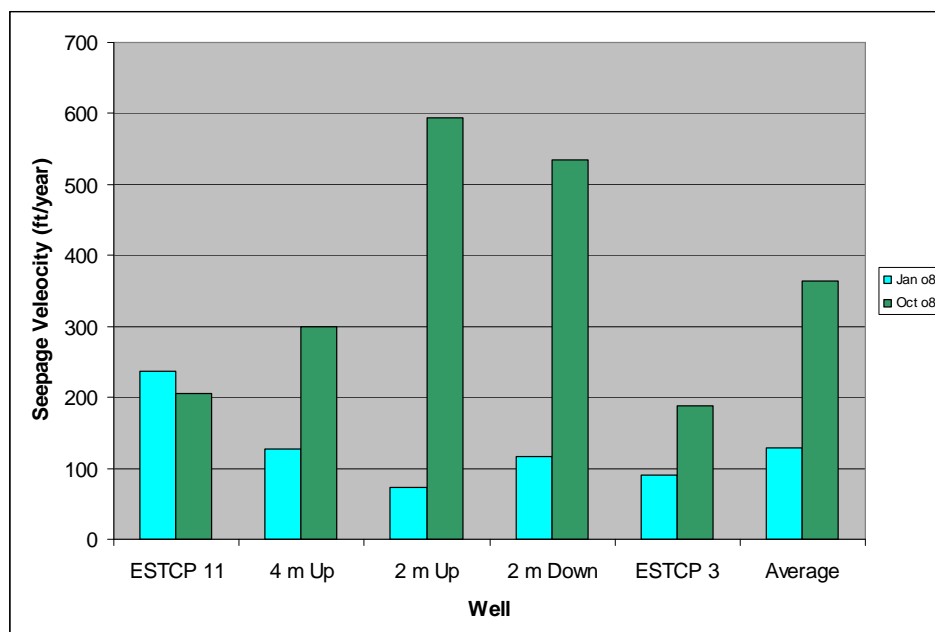
Figure 47 - Estimates of groundwater seepage velocities based on tracer dilution tests conducted in January and October of 2008.

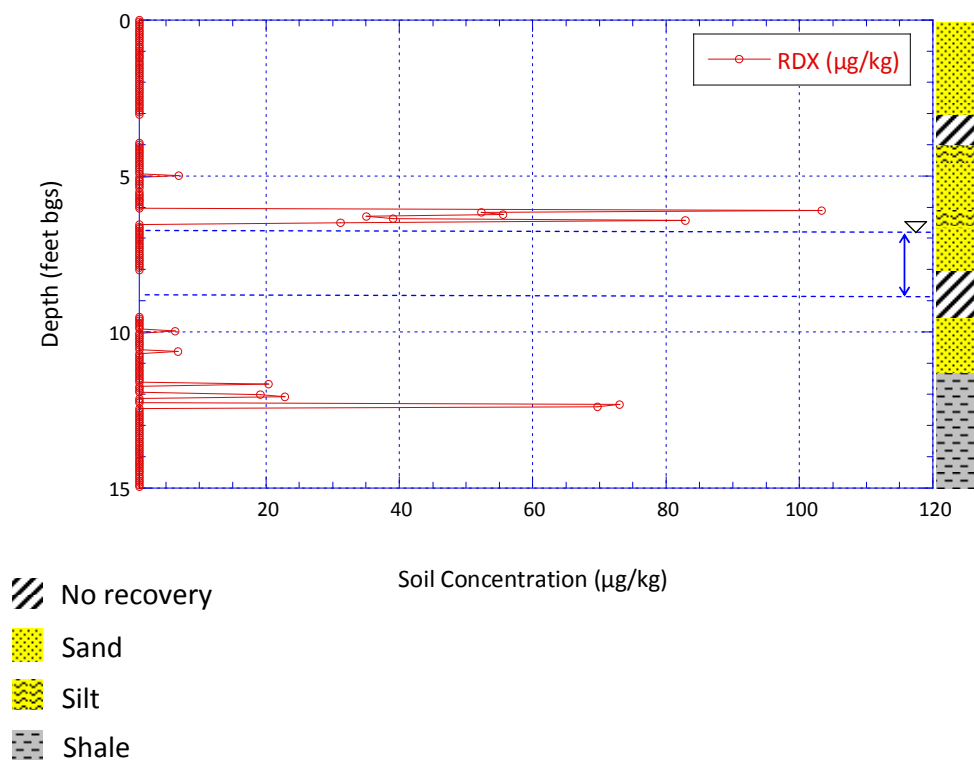
Figure 51 - Data from soil core 2,4,6-TNTMW-02: energetic compounds versus depth.

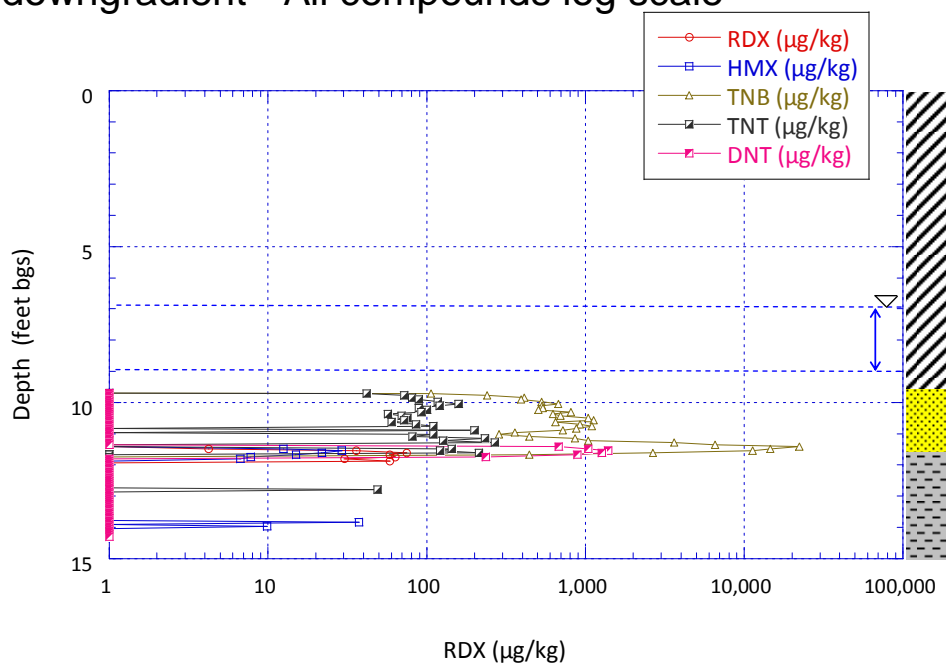
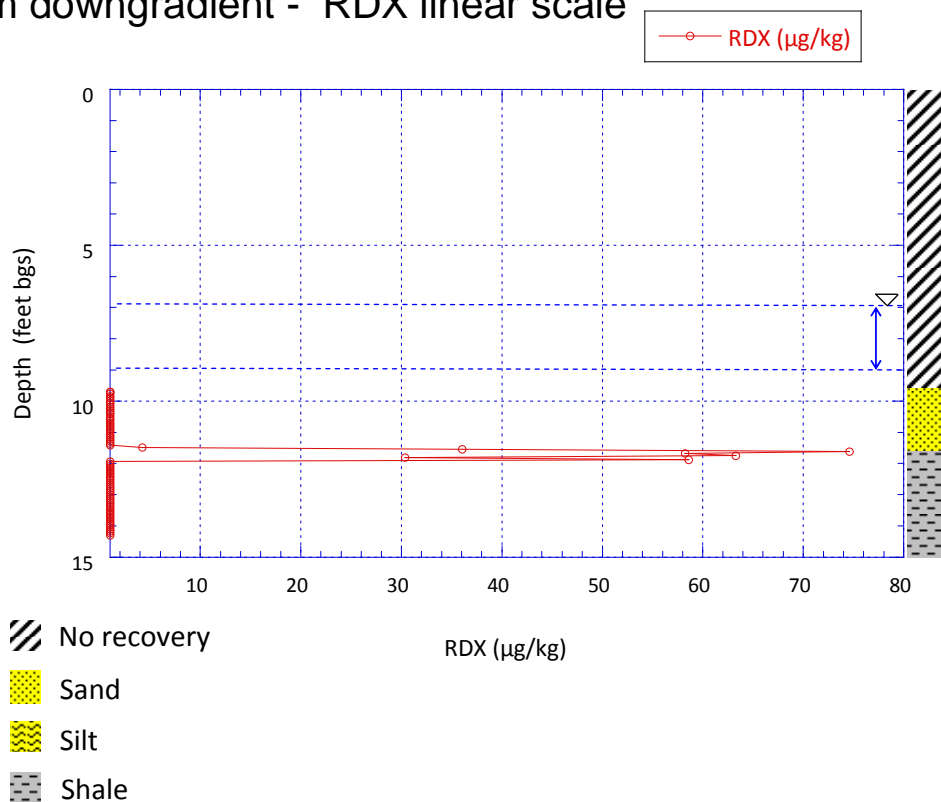
Figure 52 - Data from soil core collected 2 meters downgradient of e-barrier: energetic compounds versus depth.

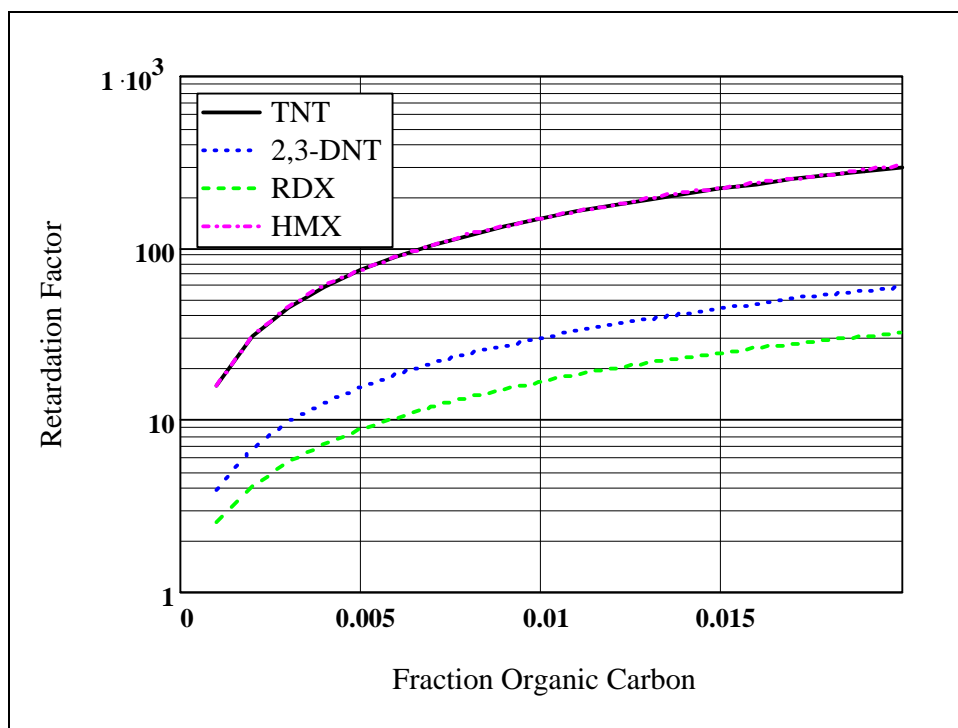
Figure 54 - Retardation factors for 2,4,6-TNT, 2,3-DNT, RDX, and HMX as a function of fraction organic carbon.

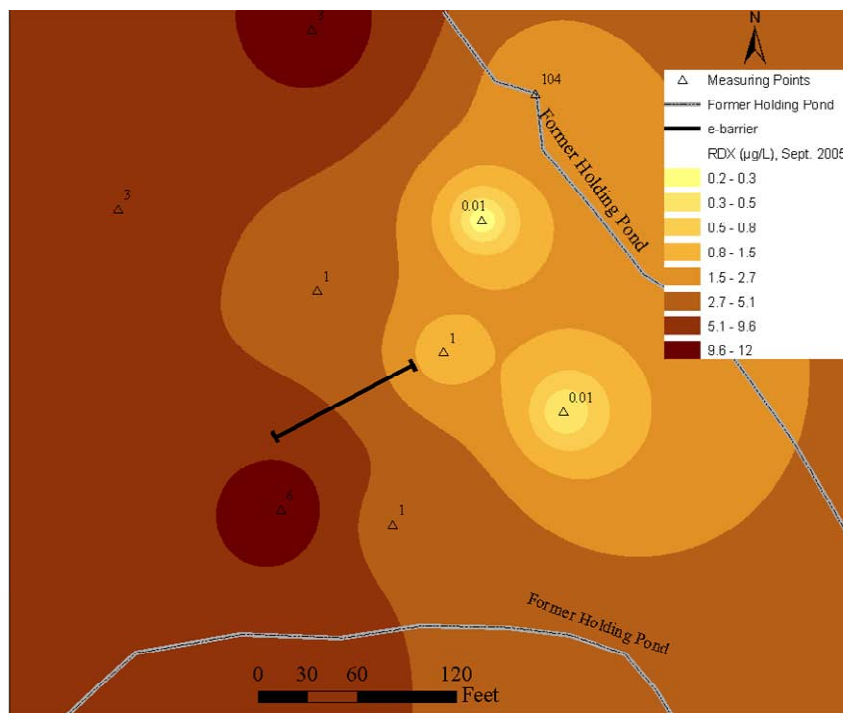
Figure 57 – Initial concentrations of RDX in groundwater.
